Evaluating Benthic Habitats and Sedimentation in the Headwaters of Deckers Creek, Preston County, WV

Luis Cervantes

Eliza Siefert

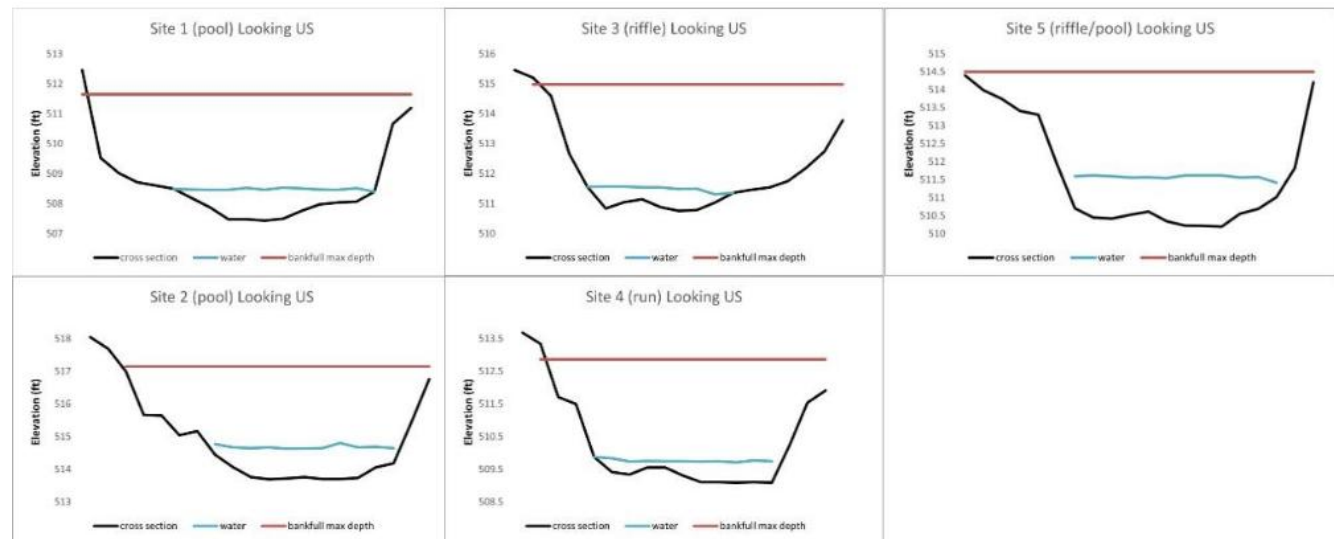
- Water quality & stream flow taken during each visit:
 - pH, streamflow & dissolved solids concentration found be at acceptable levels
 - dissolved oxygen at low end of optimal levels
- Cross sectional survey conducted of the streambed profile
 - High erosion & sediment deposition evident throughout stream reach
 - Highly channelized banks along entirety of both shorelines

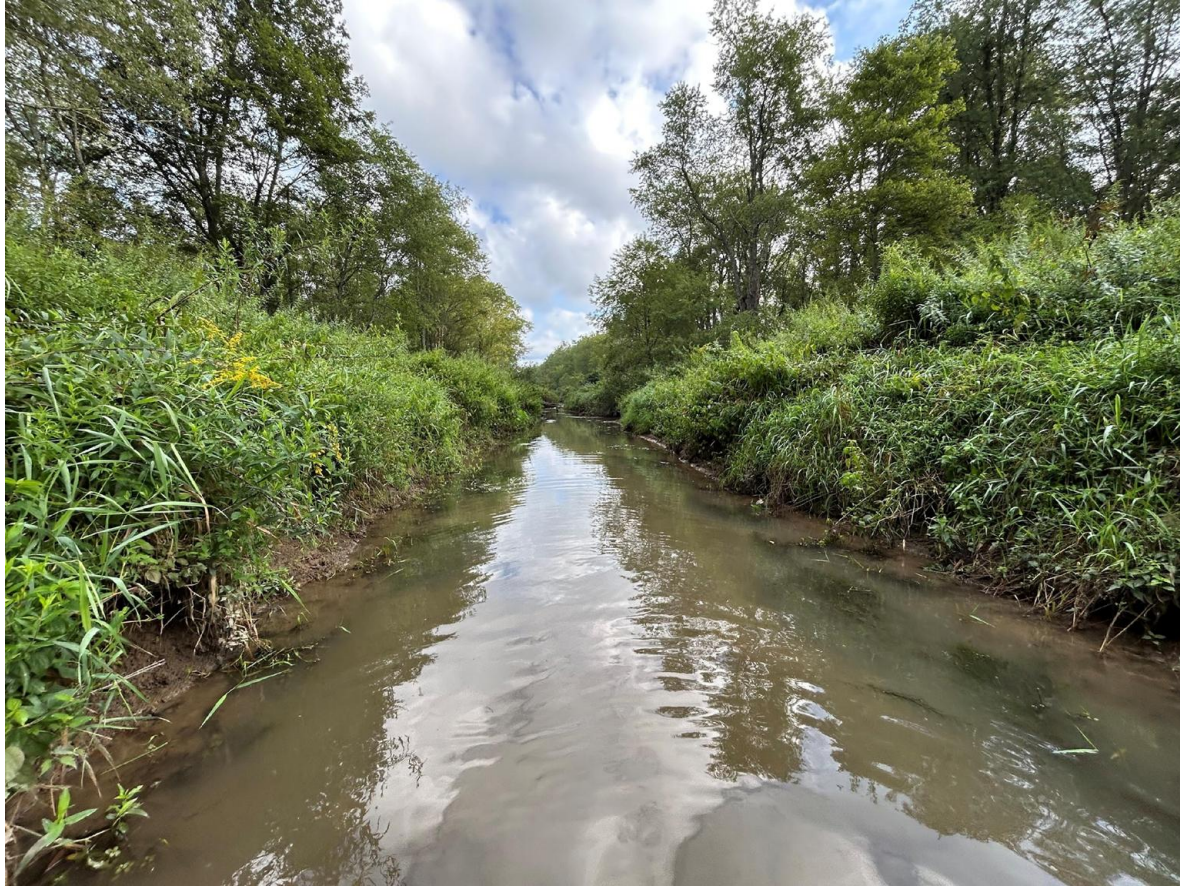
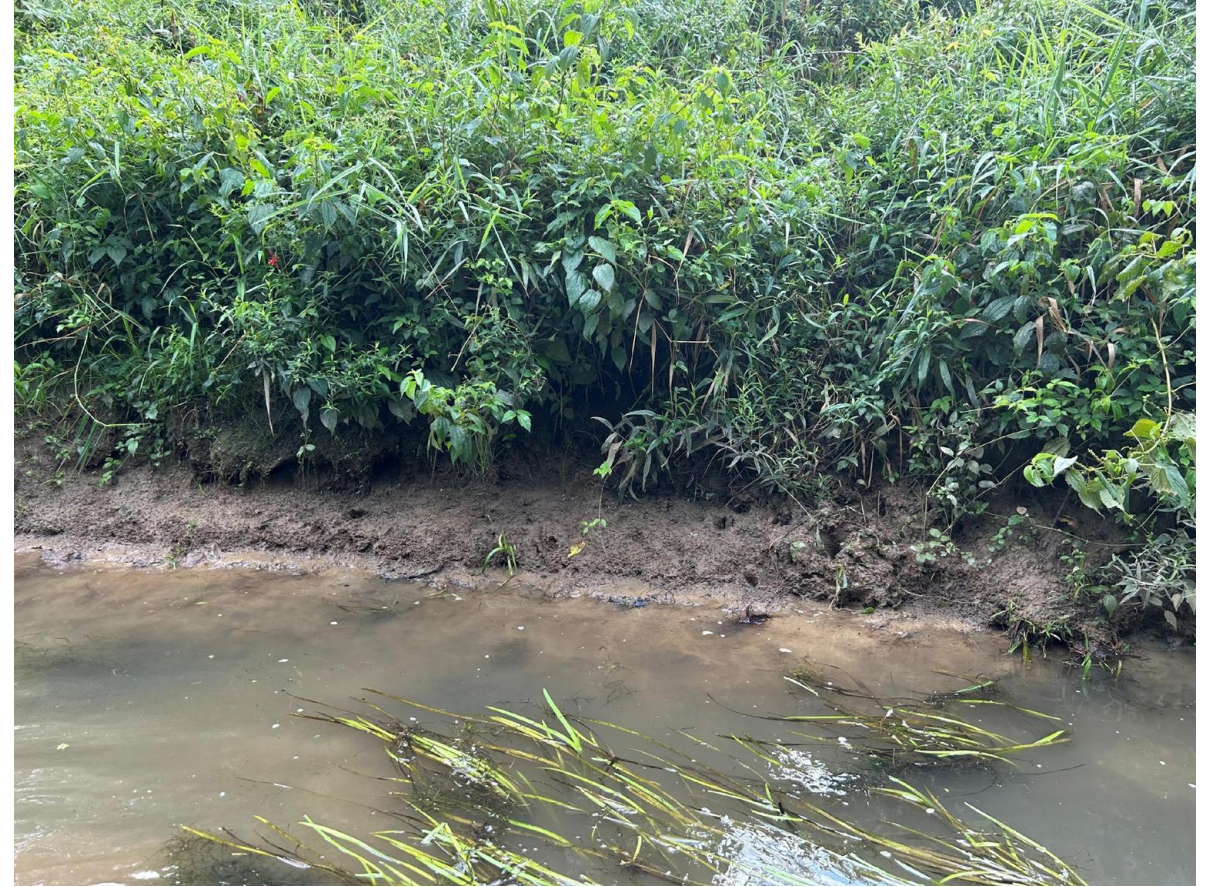
- Erosion pins were installed in fall of 2025 and have been monitored monthly
 - all subsections evidence of both erosion and deposition at varying rates.
- Subsections A, B & C have experienced significant deposition
- Stream bank monitoring will continue through the spring as habitat improvement structures are implemented

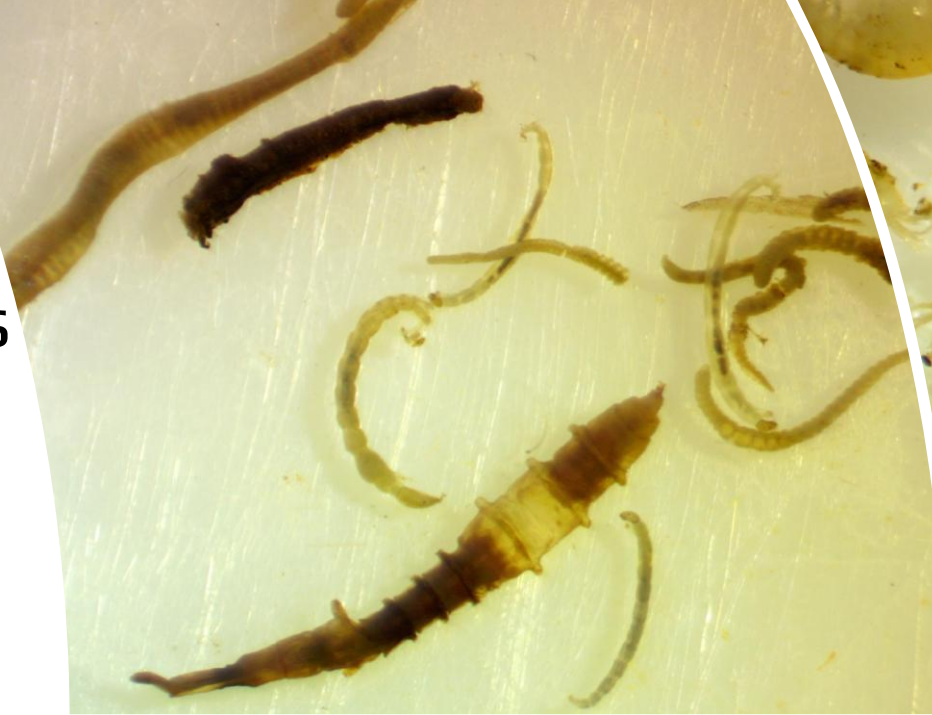
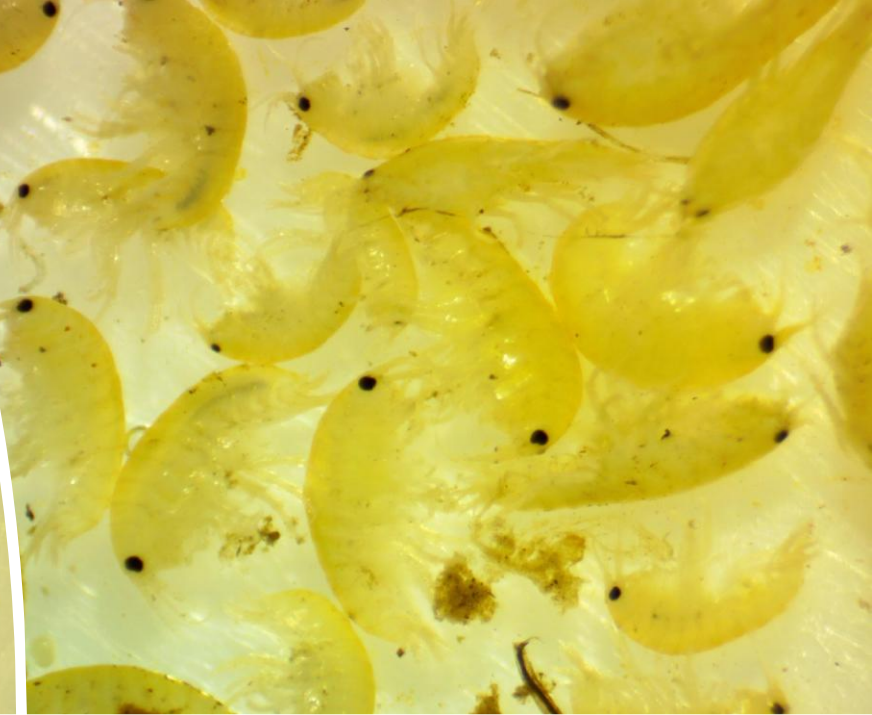
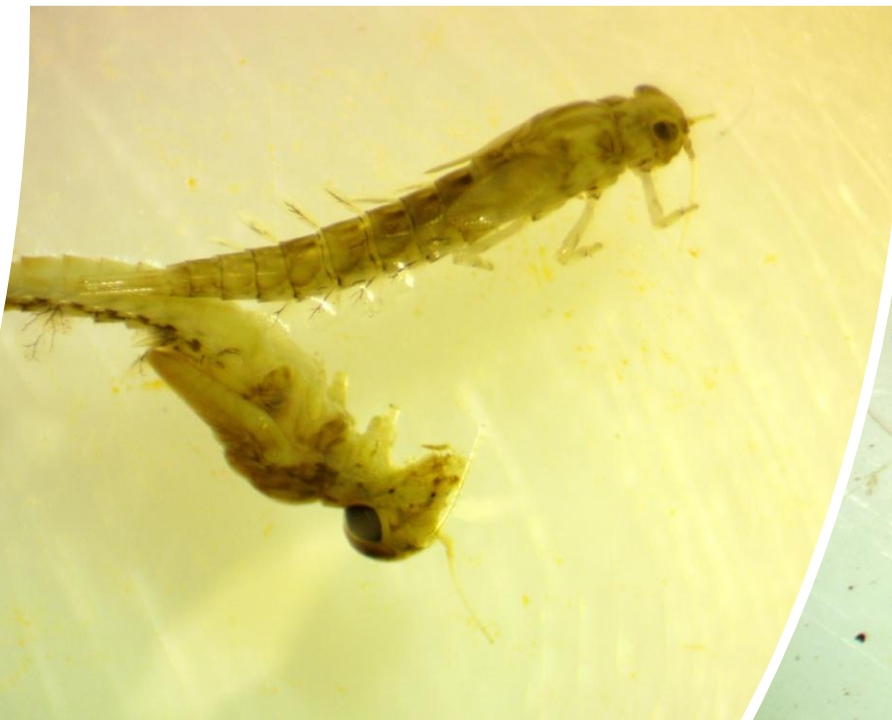
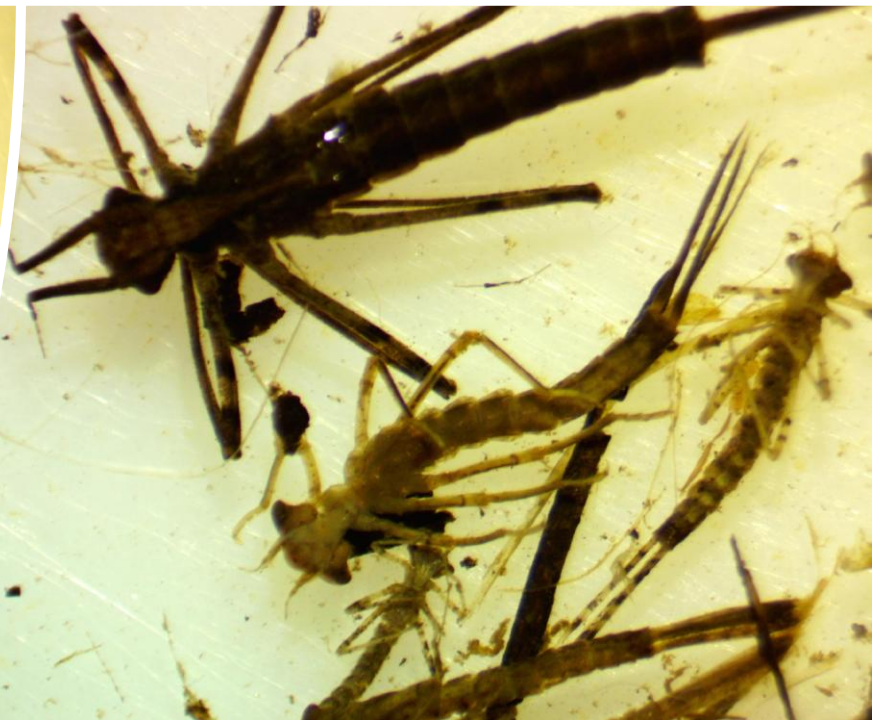
- Initial survey found marginal benthic community I
- Dominated by mid-tolerant groups
- Small proportion of sensitive taxa found, likely due to bottom substrate characteristics

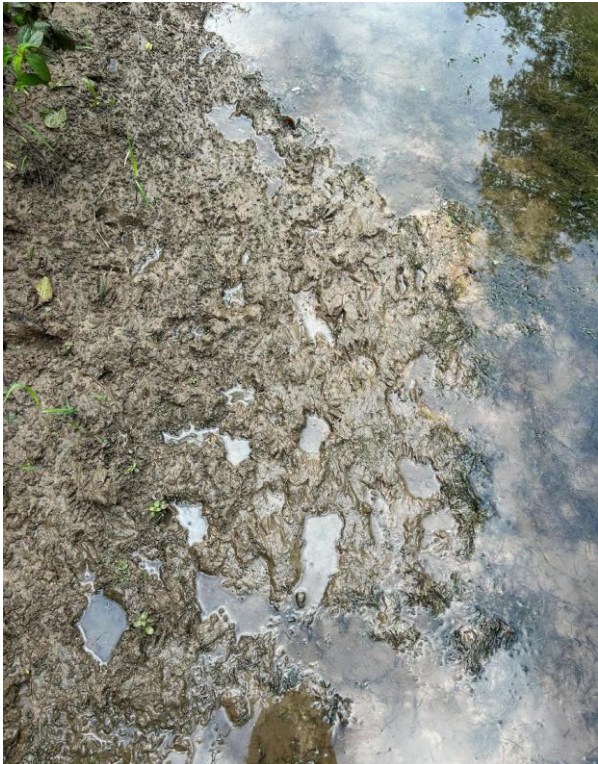
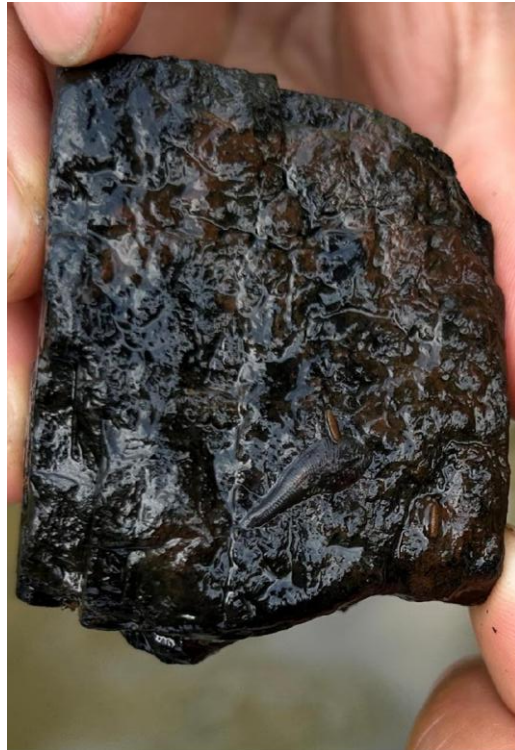
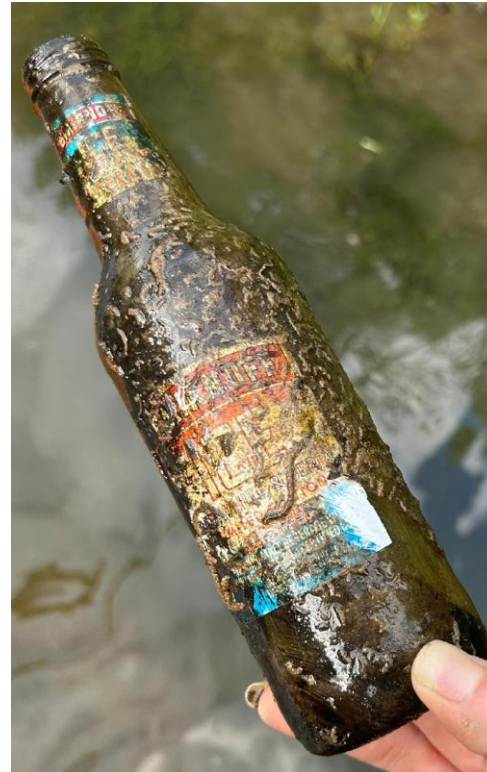
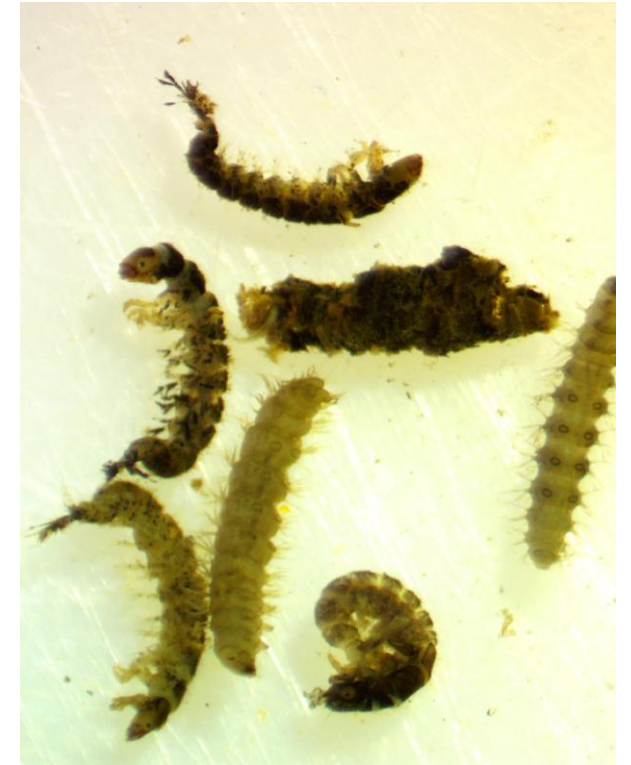
- Bottom substrate of stream largely composed of fine sediment mud/sand bottoms
- Submerged Aquatic Vegetation (SAVs) present as second largest habitat type
- Few if any coarse substrate
 - Likely due to high sediment loads/characteristics of stream
