Watershed Scale Approaches to  
AMD Remediation:  
Martin Creek and Sandy Creek  
WV 342

Final Report

Prepared for: West Virginia Department of Environmental Protection  
Office of Special Reclamation

By: Paul Ziemkiewicz, Director  
Melissa O'Neal, Project Manager  
West Virginia Water Research Institute  
West Virginia University

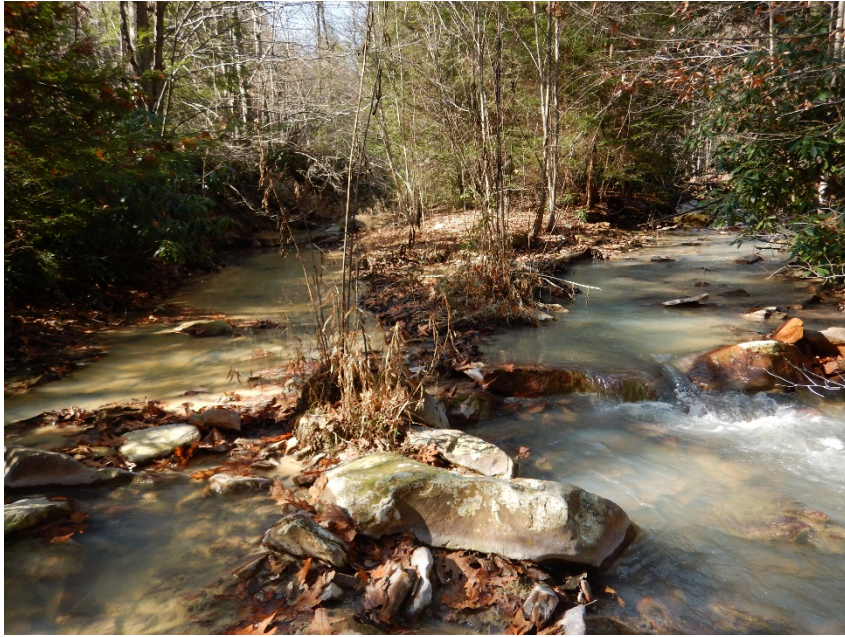
*Figure 6. MUF site during average flow conditions on 15 November 16. Only G1 doser operational.*

Figure 6 and Figure 7 depict average and high flow conditions at MUF compliance point while doser was operational.

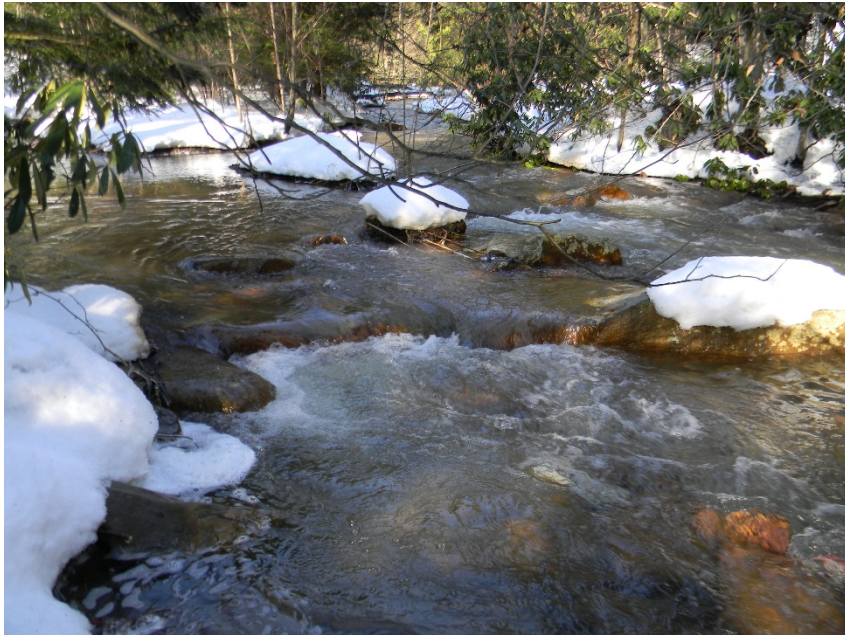
*Figure 7. MUF site during high flow conditions on 2 February 16. Both G1 and M1 dosers operational.*

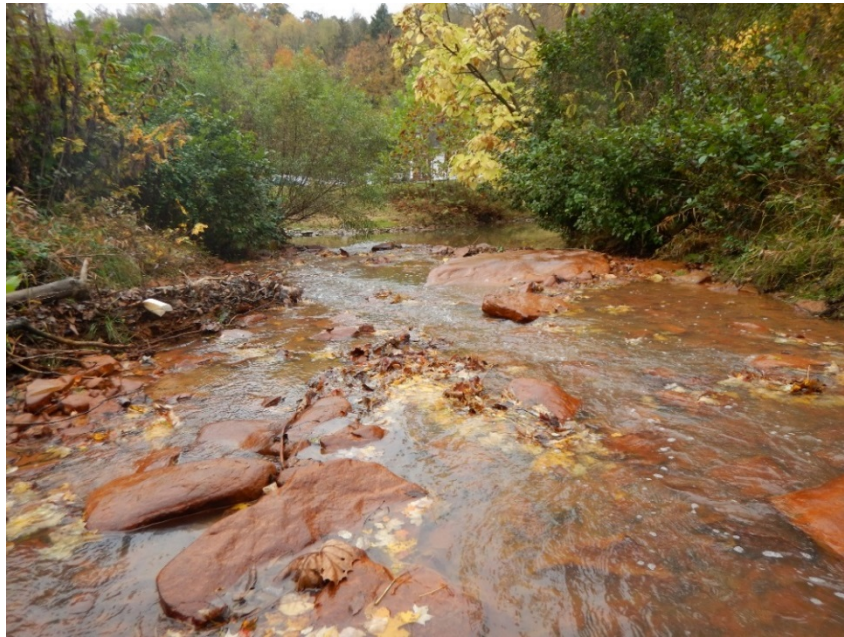
Figure 13. LFLSM site during low flow conditions on 19 October 16. Doser operational.

Figure 13 and Figure 14 depict low and high flow conditions at LFLSM compliance point while doser was operational.

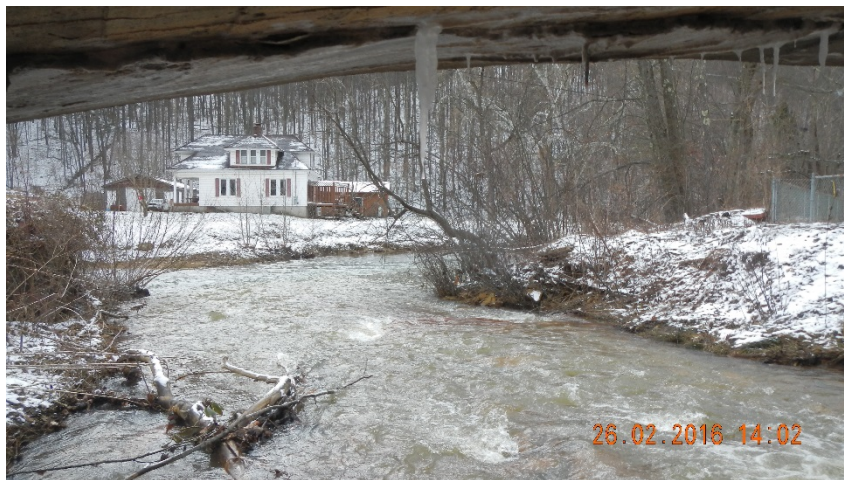
Figure 14. LFLSM site during high flow conditions on 26 February 16. Doser operational.

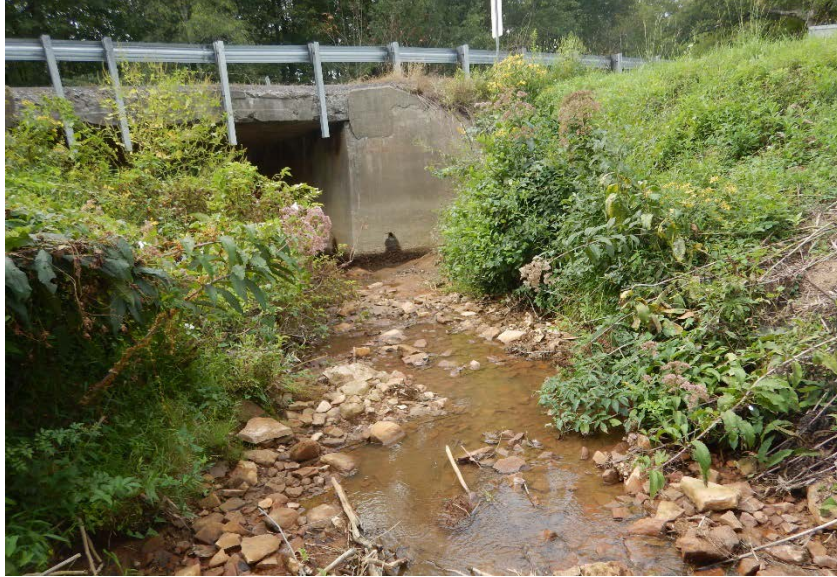
Figure 15. MRM site during low flow conditions on 7 Sept 16. Doser operational.

Figure 15 and Figure 16 depict low and high flow conditions at MRM compliance point while doser was operational.

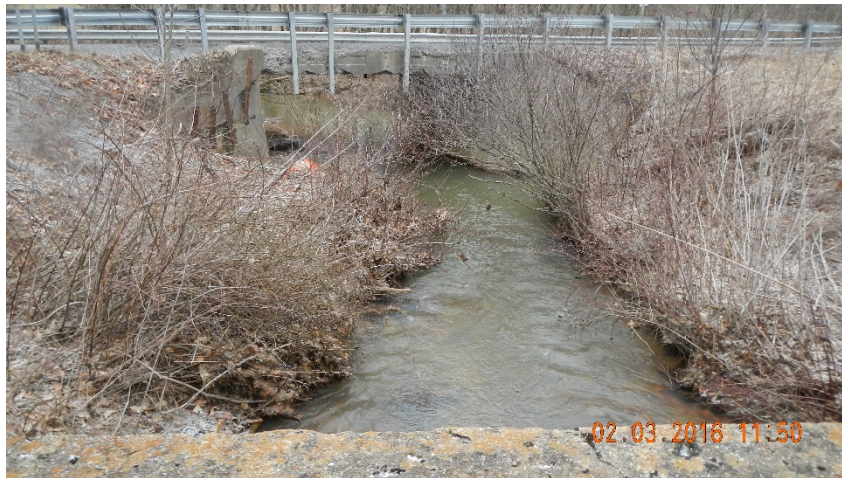
Figure 16. MRM site during high flow conditions on 2 March 16. Doser operational.
